## THE MOSAIC PAVEMENT SUBSTRATES IN THE SOUTHERN ROOMS OF THE EASTERN CHURCH AT KHIRBET ET-TIREH, RAMALLAH (PALESTINE)

Salah Hussein AL-HOUDALIEH\* and Hamdallah BEARAT\*\*

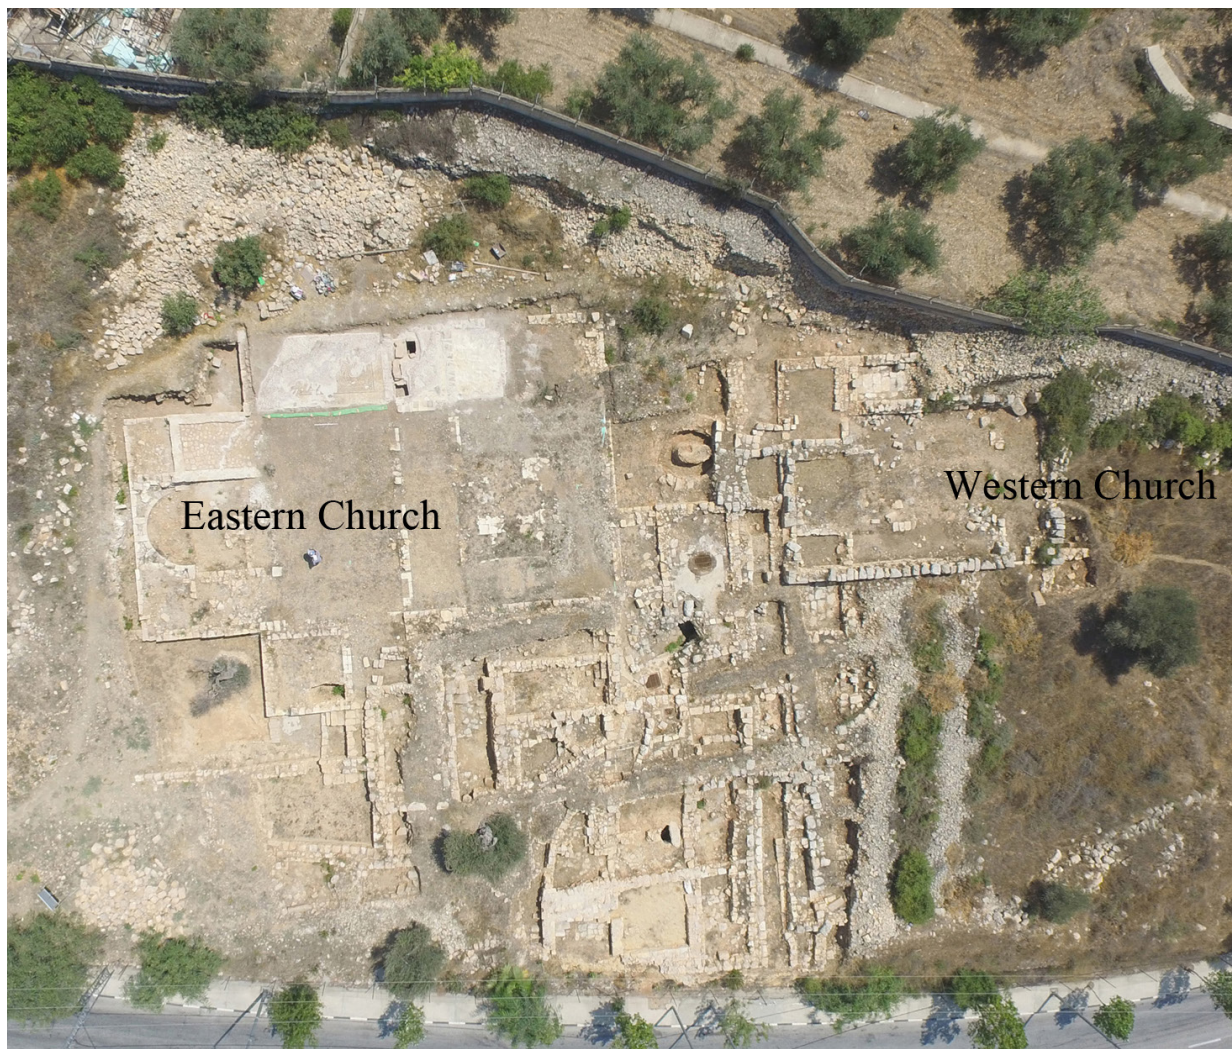
FIG. 2. Aerial photograph showing the excavated areas at Khirbet et-Tireh, 2018 (photo by N. Fetyani).

campaign, our teams had excavated a total area of approximately 1,750 m<sup>2</sup>. Among the significant architectural features uncovered are: a rock-cut, subterranean hiding complex of the Roman period; a Byzantine-Umayyad fortification system; two Byzantine-Umayyad churches –designated ‘Eastern’ and ‘Western’ from their relative locations–; several Byzantine-era burial caves and ground graves; a Byzantine-Umayyad subterranean oil press complex; a Byzantine-Umayyad rock-cut cistern with two feeder channels; two pathways or streets leading to the churches; several residential units from the Byzantine to Early Abbasid periods; and numerous

Ottoman-period agricultural terraces (Fig. 2) (Al-Houdalieh, 2014, 2015, 2016, 2018)<sup>2</sup>.

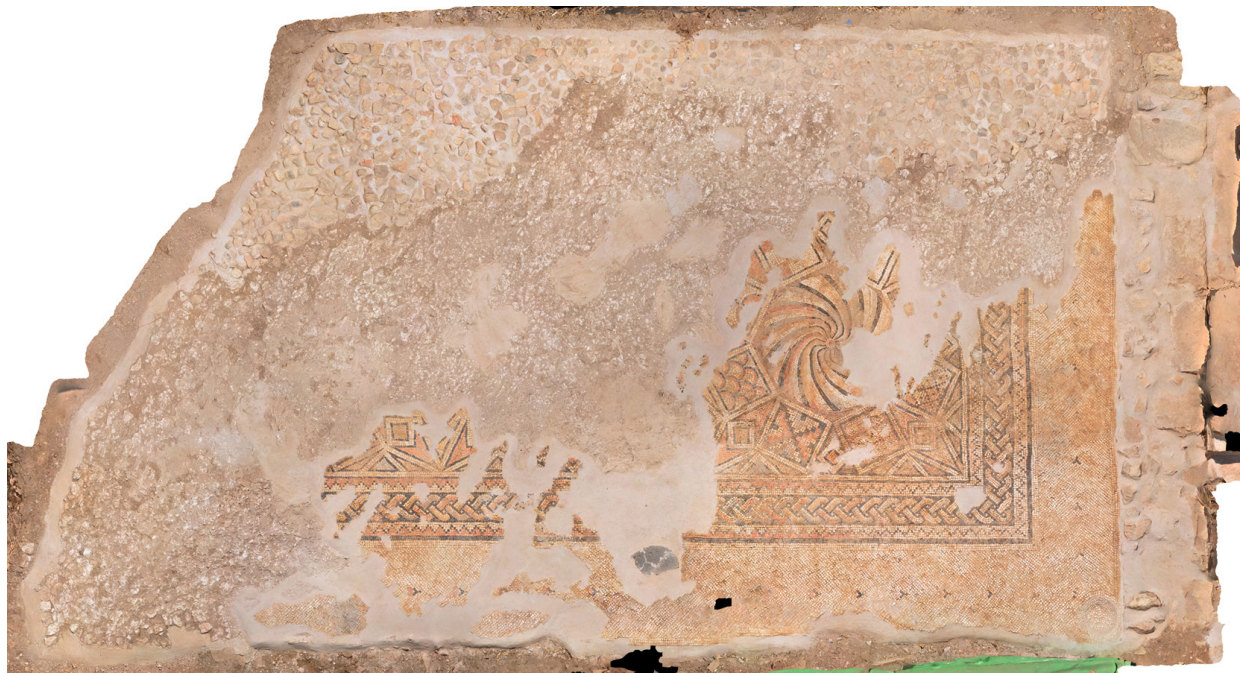
FIG. 4. *The mosaic and repair of the floor pavement of Room 4 (photo by N. Fetyani).*

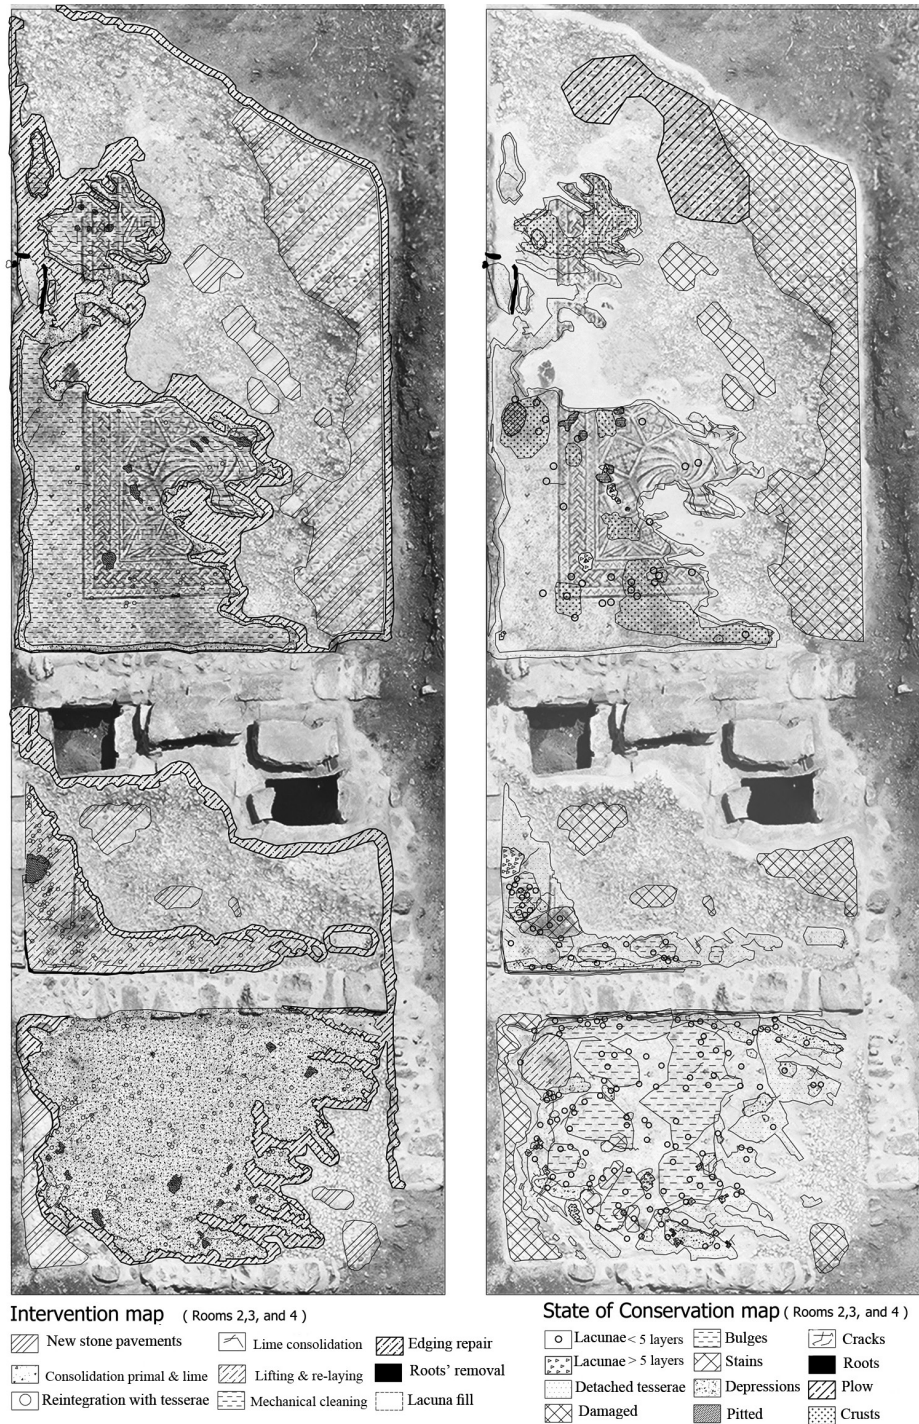
FIG. 5. *Condition assessment and intervention map (prepared by R. Khalil).*

2) Documenting the physical condition of the mosaic pavements through visual inspection and textual recording; preparing a series of thematic charts detailing the physical condition of the surveyed pavements, especially noting all visible problems (Fig. 5); compiling a written description of the problems relating to these floors; and finally, formulating a detailed action plan for intervention.

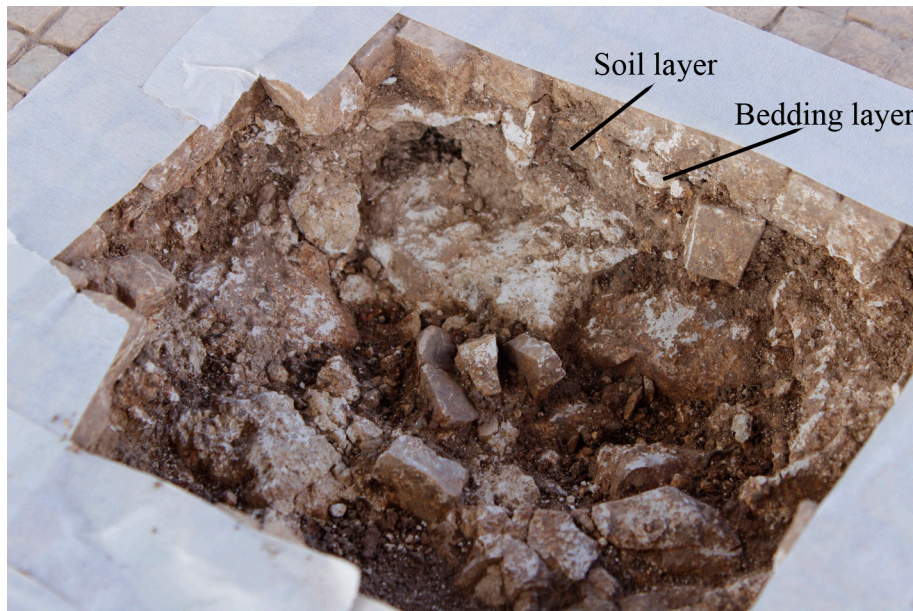
FIG. 7. The soil layer in between the bedding layer and nucleus in Room 2.

lacunae or cracks–, and the results of this work revealed the same soil layer seen elsewhere, extending beneath the intact section of this floor (Fig. 7). Furthermore, when we lifted the mosaic floor of Room 3, we again found a soil layer of the same characteristics, composition and thickness as those found in Rooms 4 and 2 (Figs. 8-9). So, we can conclude that the soil layers found in Rooms 4, 3 and 2 between the *nucleus* and bedding layers are an original part of the foundation layers of these mosaic

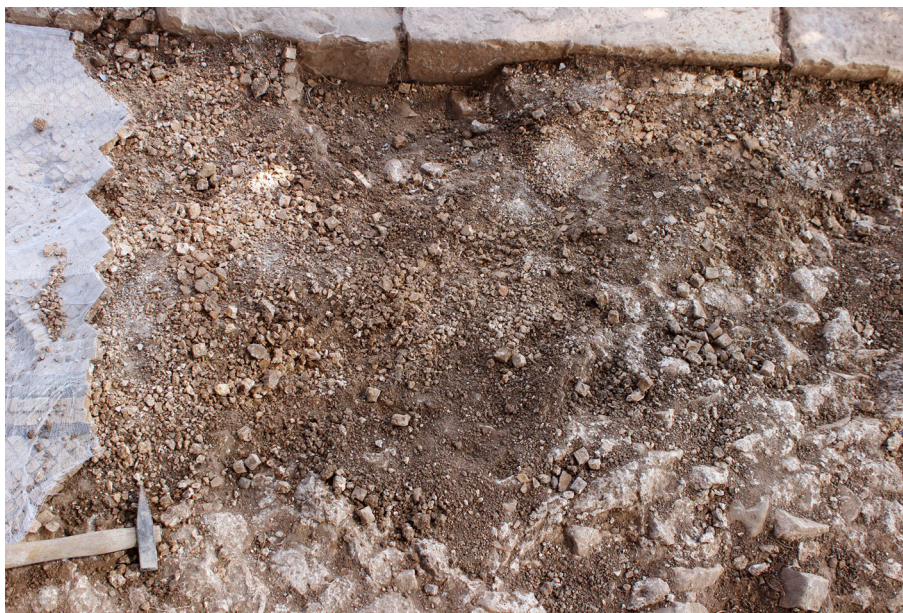
FIG. 8. Remains of the bedding and soil layer after lifting a mosaic section in Room 3.

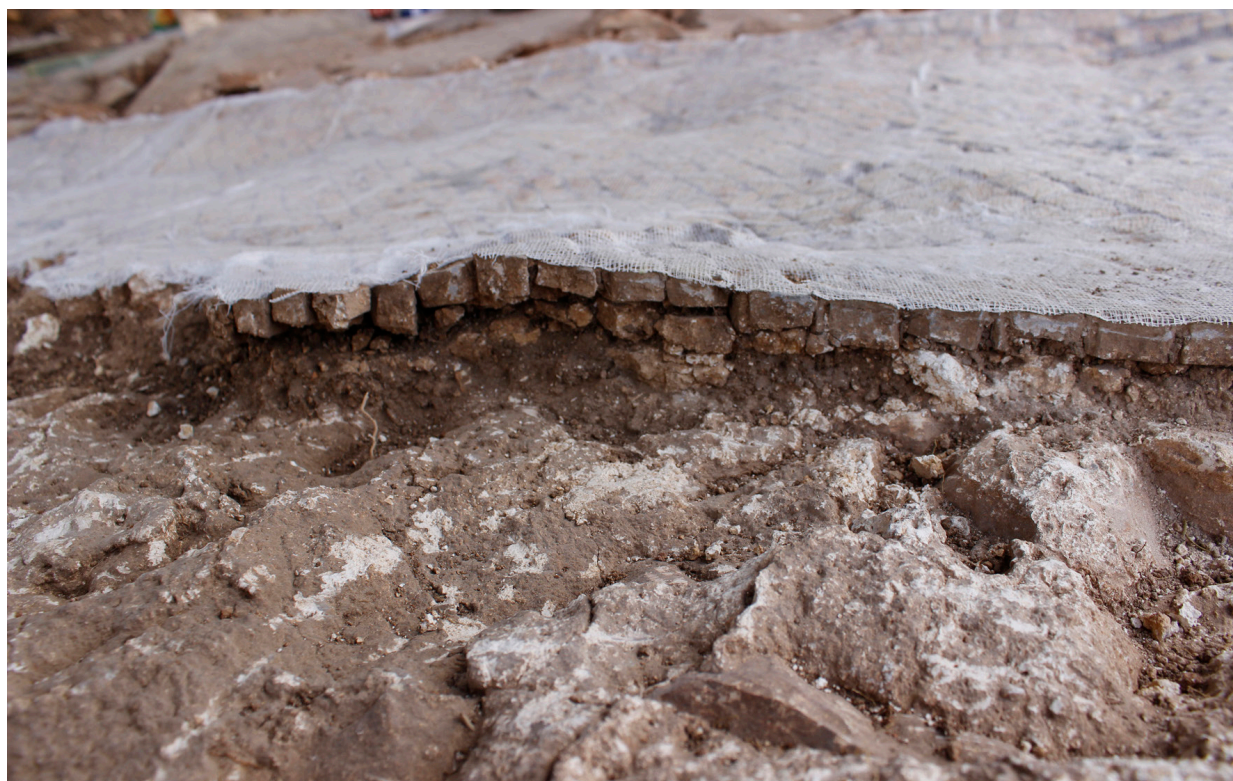
FIG. 9. *The soil layer in between the bedding layer and nucleus in Room 3.*

pavements. The thickness of this 'extra' layer ranges between 1 cm and 3 cm, depending on the regularity of the surface of the underlying *nucleus* layer (Fig. 9). For further details on its composition, please see the following section.

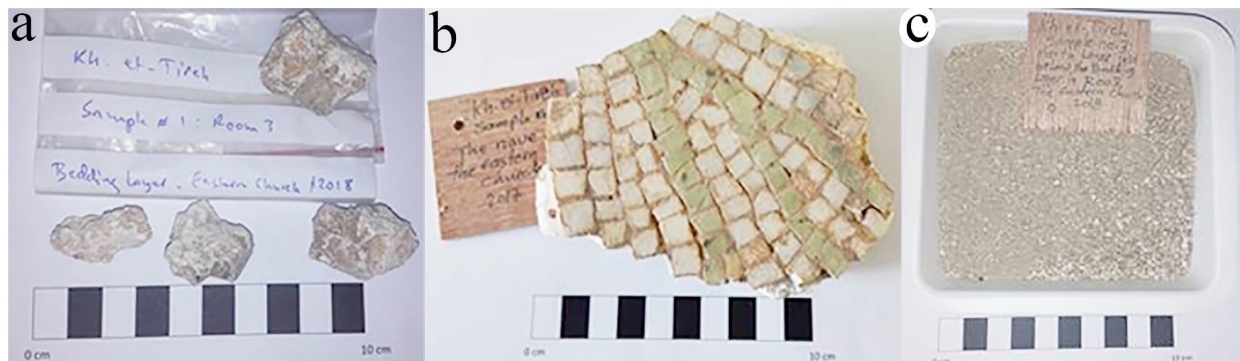
FIG. 10. Samples studied: (a) Sample # 1 consisting of several fragments of the mosaic from Room # 3 of the Eastern Church taken in 2018; (b) sample # 2 consisting of a mosaic fragment taken from the nave of nave of the Easter Church in 2017; (c) sample #3, taken from an earth layer found just below the bedding layer in Room # 3 of the Eastern Church.

(plaster); the other one comes from an earth layer located just below the bedding plaster in Room # 3. Fig. 10 below shows these three samples, respectively. In sample # 3, fragments include the bedding plaster still attached to a mosaic cube.

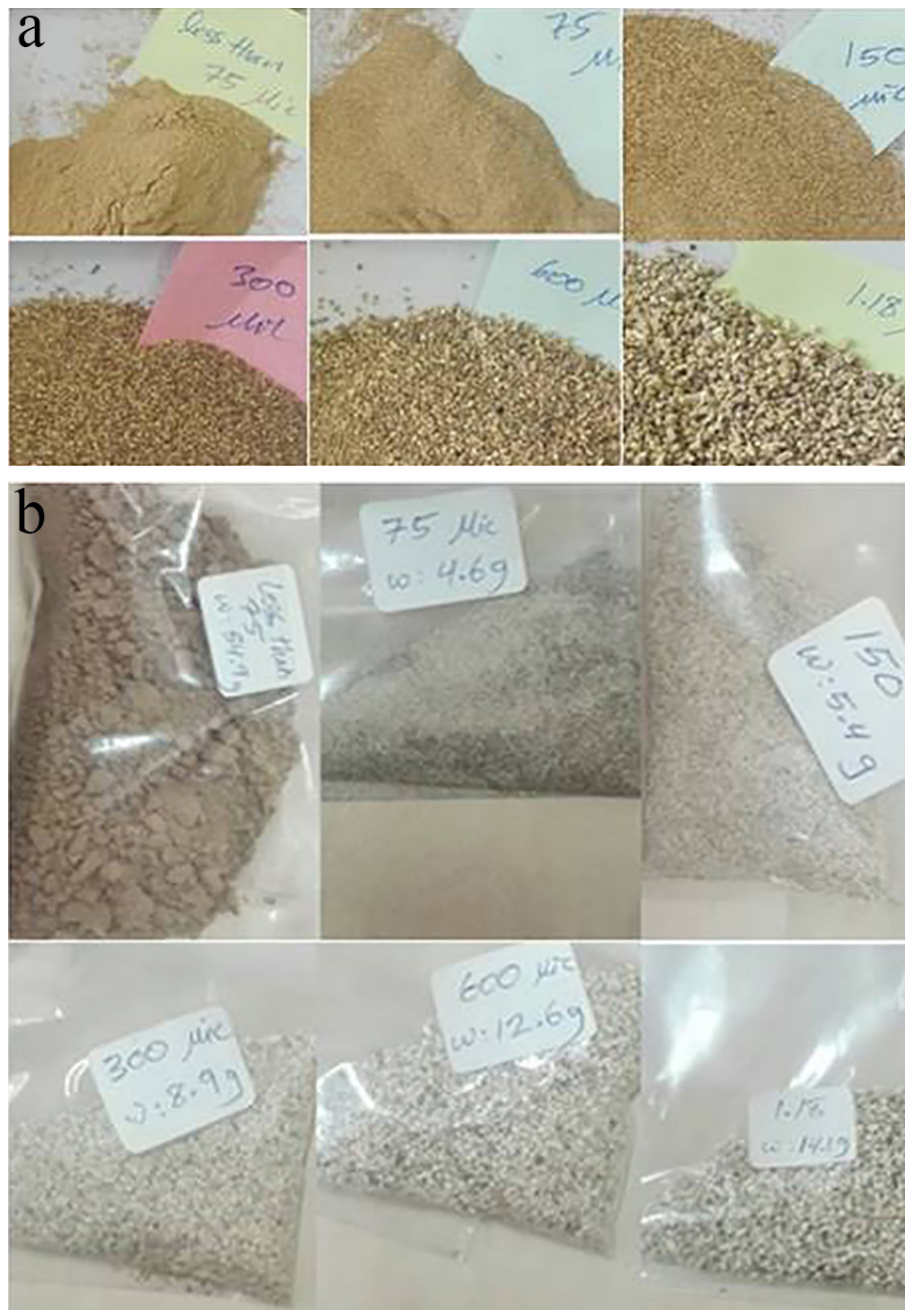
FIG. 13. Particle size distribution of the mosaic fill material: a) after screening of dry sample; b) after screening of wet sample.

Data obtained for the fill soil sample screened dry are presented in Fig. 12. The table also shows data obtained for the same sample screened suspended in water. Collected size fractions in both tests are shown in Fig. 13a and b, respectively. These data are presented by the histograms of Figs. 13a and 13b. Histograms show that granulometric analysis of dry fill soil material is misleading in representing the proportion of the fine materials which is mainly composed of clay (Fig. 14a). The fine fraction –<75 $\mu$ – is underestimated and only makes about 12% of the total mass. Otherwise, the sand fractions are overestimated due to the fact that large amount of clay is still adhering to the sand particles, making grains appear larger than they are and making each size fraction higher. On the other hand, histograms of Fig. 14b provide a realistic measure of the grain size distribution of both the sand and the clay materials. Thus, the clay component amounts now to over 50%, indicating that the two materials –clayey soil and sand– were prepared in a 1:1 ratio. Moreover, the particle size distribution of the sand component is now meaningful. The wt.% of size fractions increases as the particle size increases. There is an artificial cut in particle size at 2000 $\mu$ . It is worth noting that the sieve with 2000 micron opening did not retain any sand material. This indicates the voluntary elimination of any larger particles. One can claim that a sieve of 2000 $\mu$  (= 2 mm) size opening –us mesh 10– was employed to screen the sand material before mixing it with equal proportion of clay material.

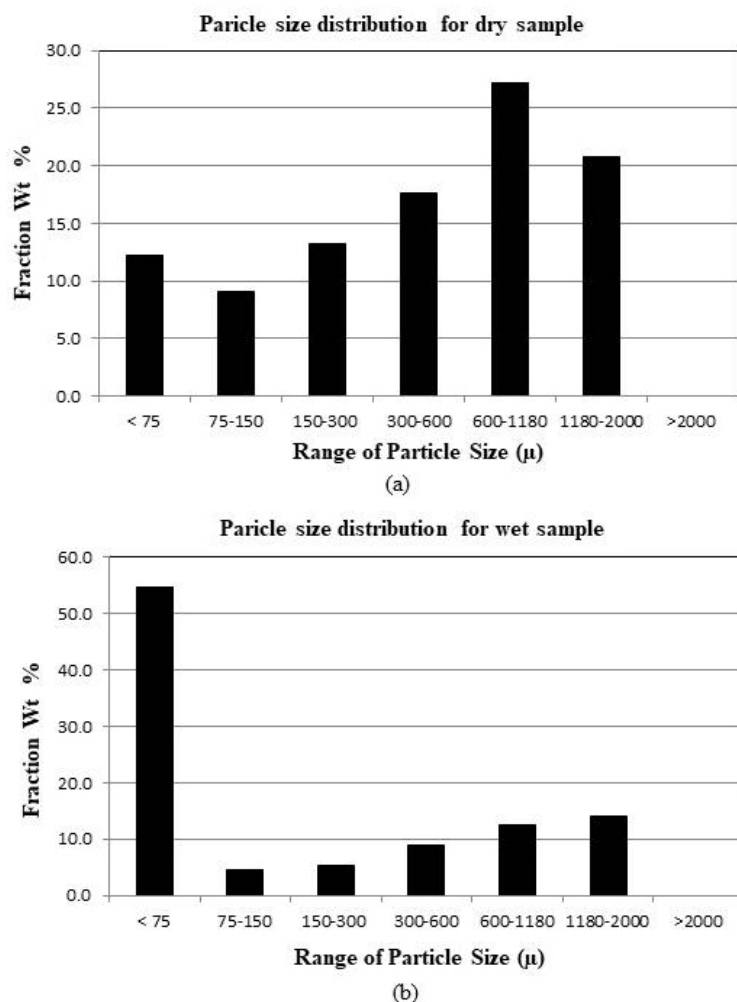
FIG. 14. *Different size fraction of the fill soil material after sieving. (a) dry-sieved; (b) sieved as water suspension.*

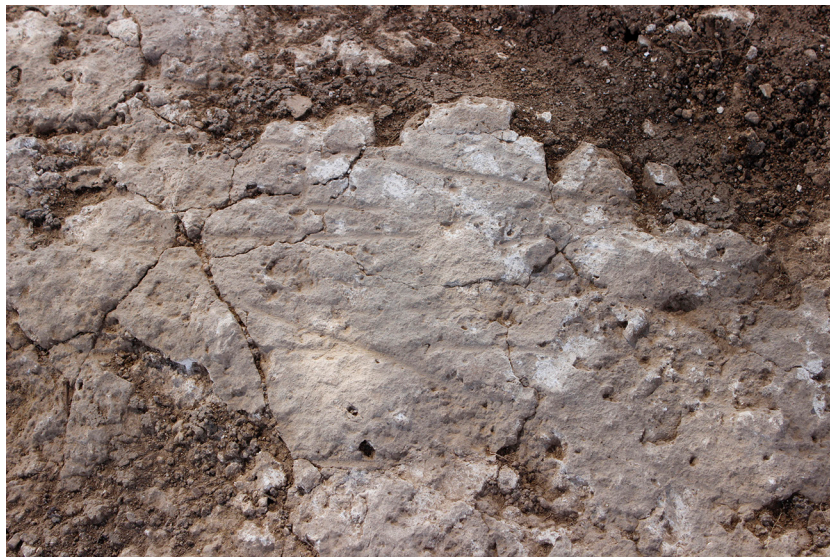
FIG. 20. *Plow marks and deep cracks on the surface of the nucleus layer in Room 4.*

The mosaics and substrates of the southern rooms, as we found them, varied in physical condition, ranging from good, through severe damage, to complete destruction. Based on the scant overlying earthen deposits –only 0.2 m to 0.4 m thick– which we excavated from the surface of the southern rooms of the Eastern Church at Khirbet et-Tireh in 2015, and also the plow marks clearly visible in the *nucleus* layer of Room 4 (Fig. 20), we

believe that the mosaics in this area of the church were dramatically damaged through agricultural activity, probably over a long period of time. The mosaics of these rooms are distinguished not only
